Tomorrow Radiosm
Signal Coverage Report
for
Hybrid IBOC DAB Booster
of
KCSN-FM
California State University Northridge
Northridge, CA

Tomorrow Radiosm Signal Coverage Report

Hybrid IBOC DAB Signal Booster

KCSN(FM) - Northridge, California

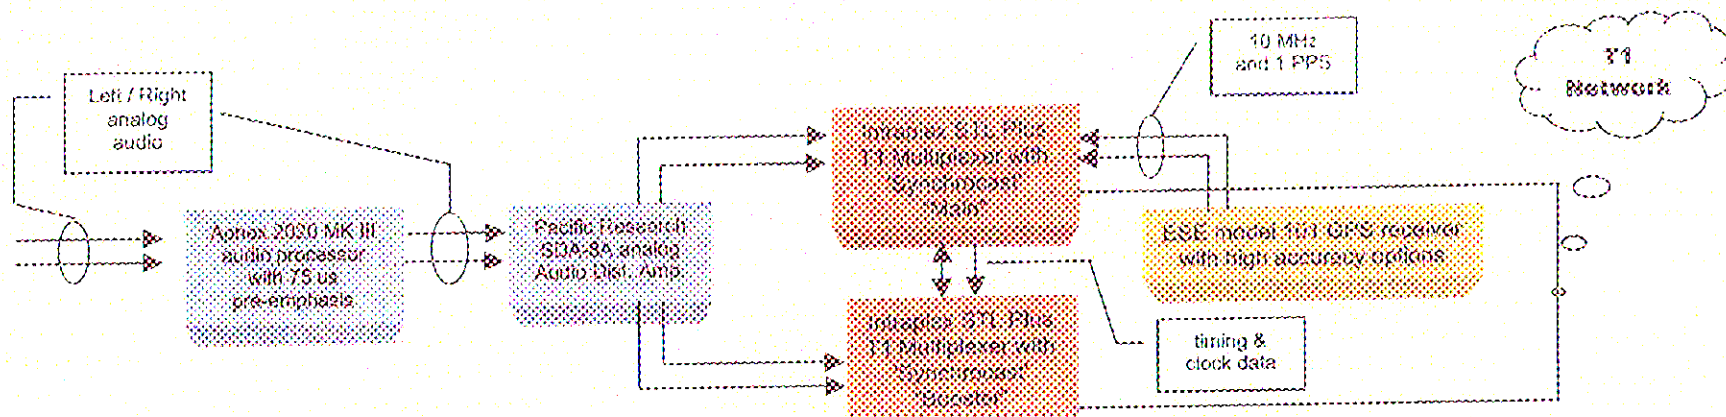
Figure 1 - Signal path diagram of KCSN Studio to T1 (1.544 Mbps) network to both main and booster.

KCSN delivers audio programming from its studios in Northridge to the primary transmitter by spread-spectrum T1 studio to transmitter link ("STL") and to the booster by leased T1 (1.544 Mbps) data circuit. To ensure that the analog and digital modulation of both sites are in synchronization despite different STL circuits and path lengths, a Harris Corp. Intraplex digital processor is utilized at the studio, as shown in Figure 1. The Intraplex is equipped with a "Synchrocast" feature that compares arrival times from each transmitter site and automatically equalizes the delays so that the signal transit time of both circuits are equal.

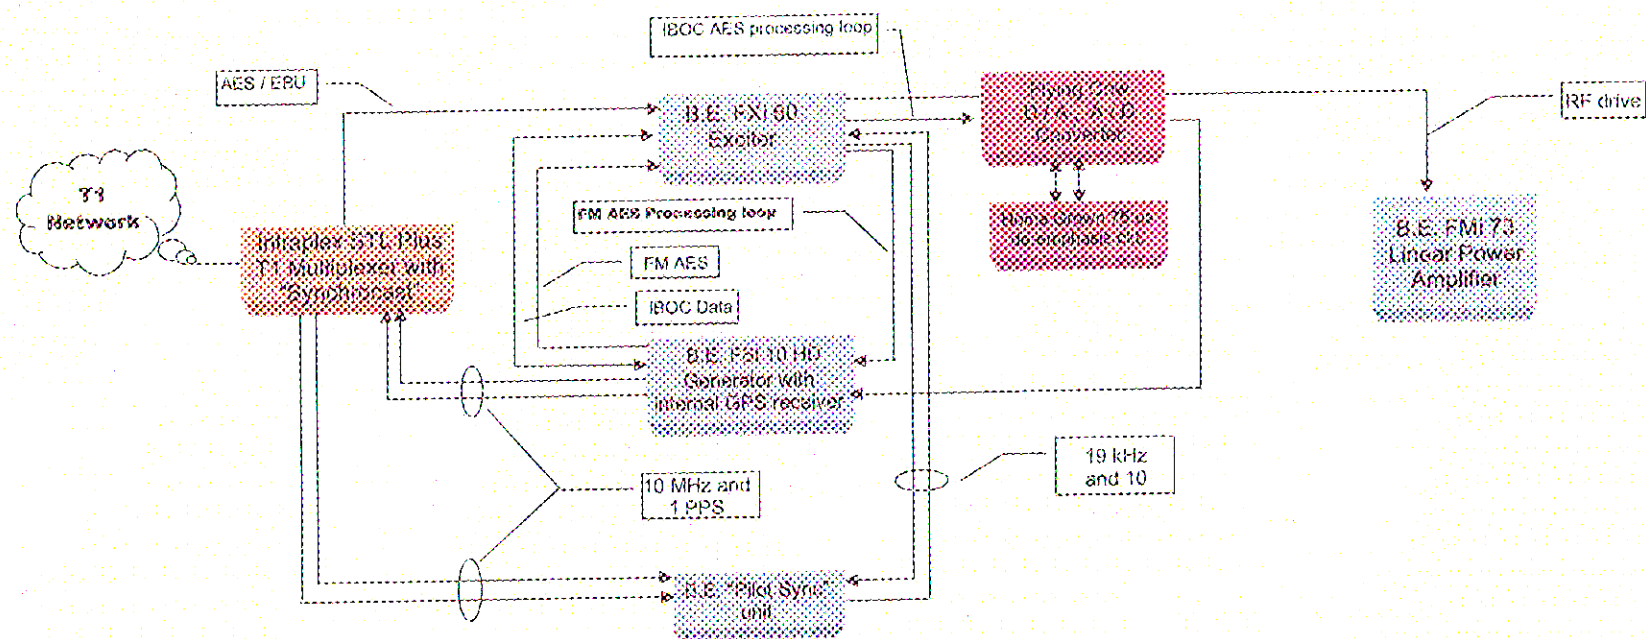
Figure 2 ~ Signal path diagram of KCSN from T1 network input to RF output. Both primary and booster transmitters are similar in configuration.

At the transmitter sites, digital audio for the Intraplex units are fed to a Broadcast Electronics Fxi60 exciter for frequency modulation of the analog host carrier (after the requisite 8 second delay to match IBOC delay time). This path is shown in Figure 2, which is nearly identical for both primary and booster systems. Since this audio is pre-emphasized for FM, the audio is passed through a D/A converter, de-emphasized to "flat" amplitude-frequency response, and passed to the B.E. FSi10 HD generator. Audio for the IBOC broadcast is encoded and returned to the Fxi60 exciter where the OFDM carriers are modulated and combined with the analog FM carrier. GPS receivers at both sites provide precise frequency and timing references.

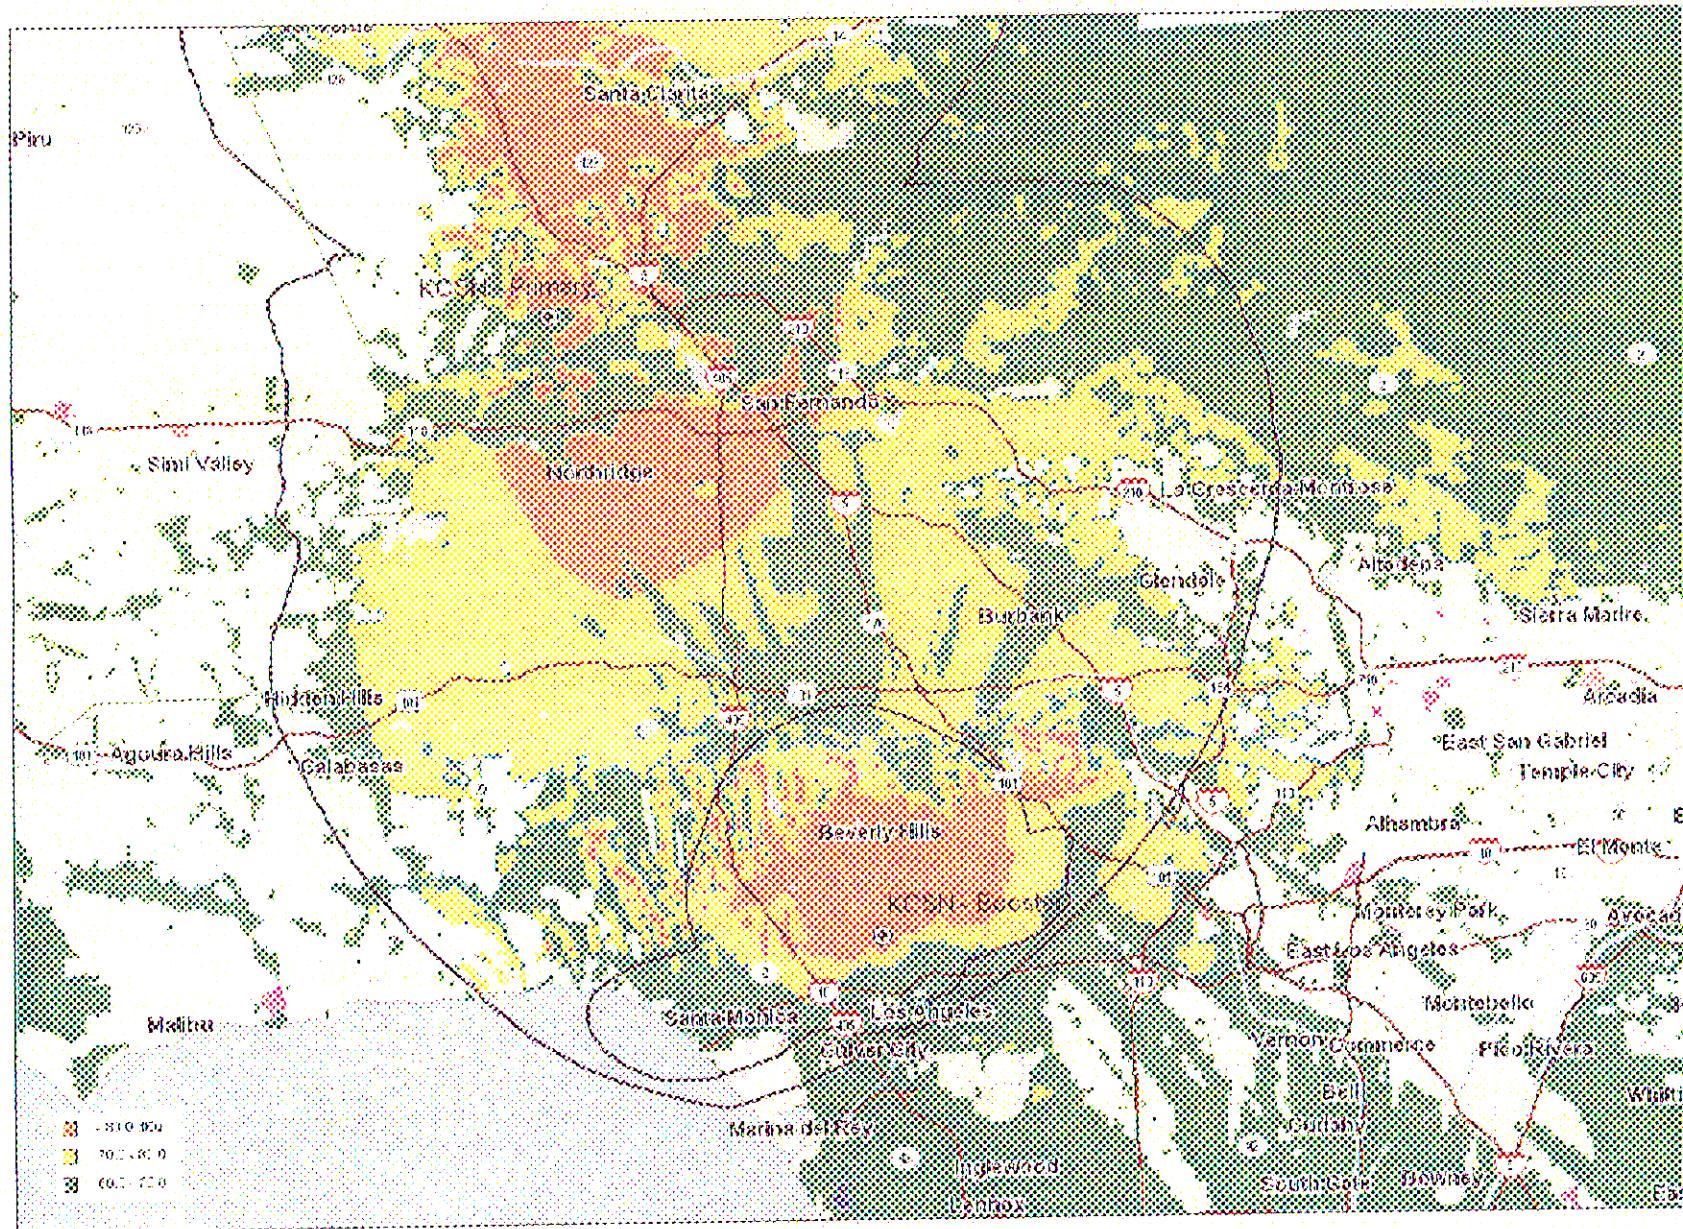
Figure 4 --Combined RCSN primary and booster coverage, showing E(50,50) 60 dBu contours over Longley-Rice field strength prediction.

The coverage map of Figure 4 shows the predicted signal reinforcement provided by the booster. It is apparent that the booster's proximity to the 60 dBu Primary service contour, shown on the map, requires substantial transmit antenna directivity to avoid contour extension. An array of two log-periodic antennas each oriented (approximately) to the northeast and northwest broaden the booster's coverage across the northern quadrants but completely maintain the 60 dBu contour within the primary service contour.

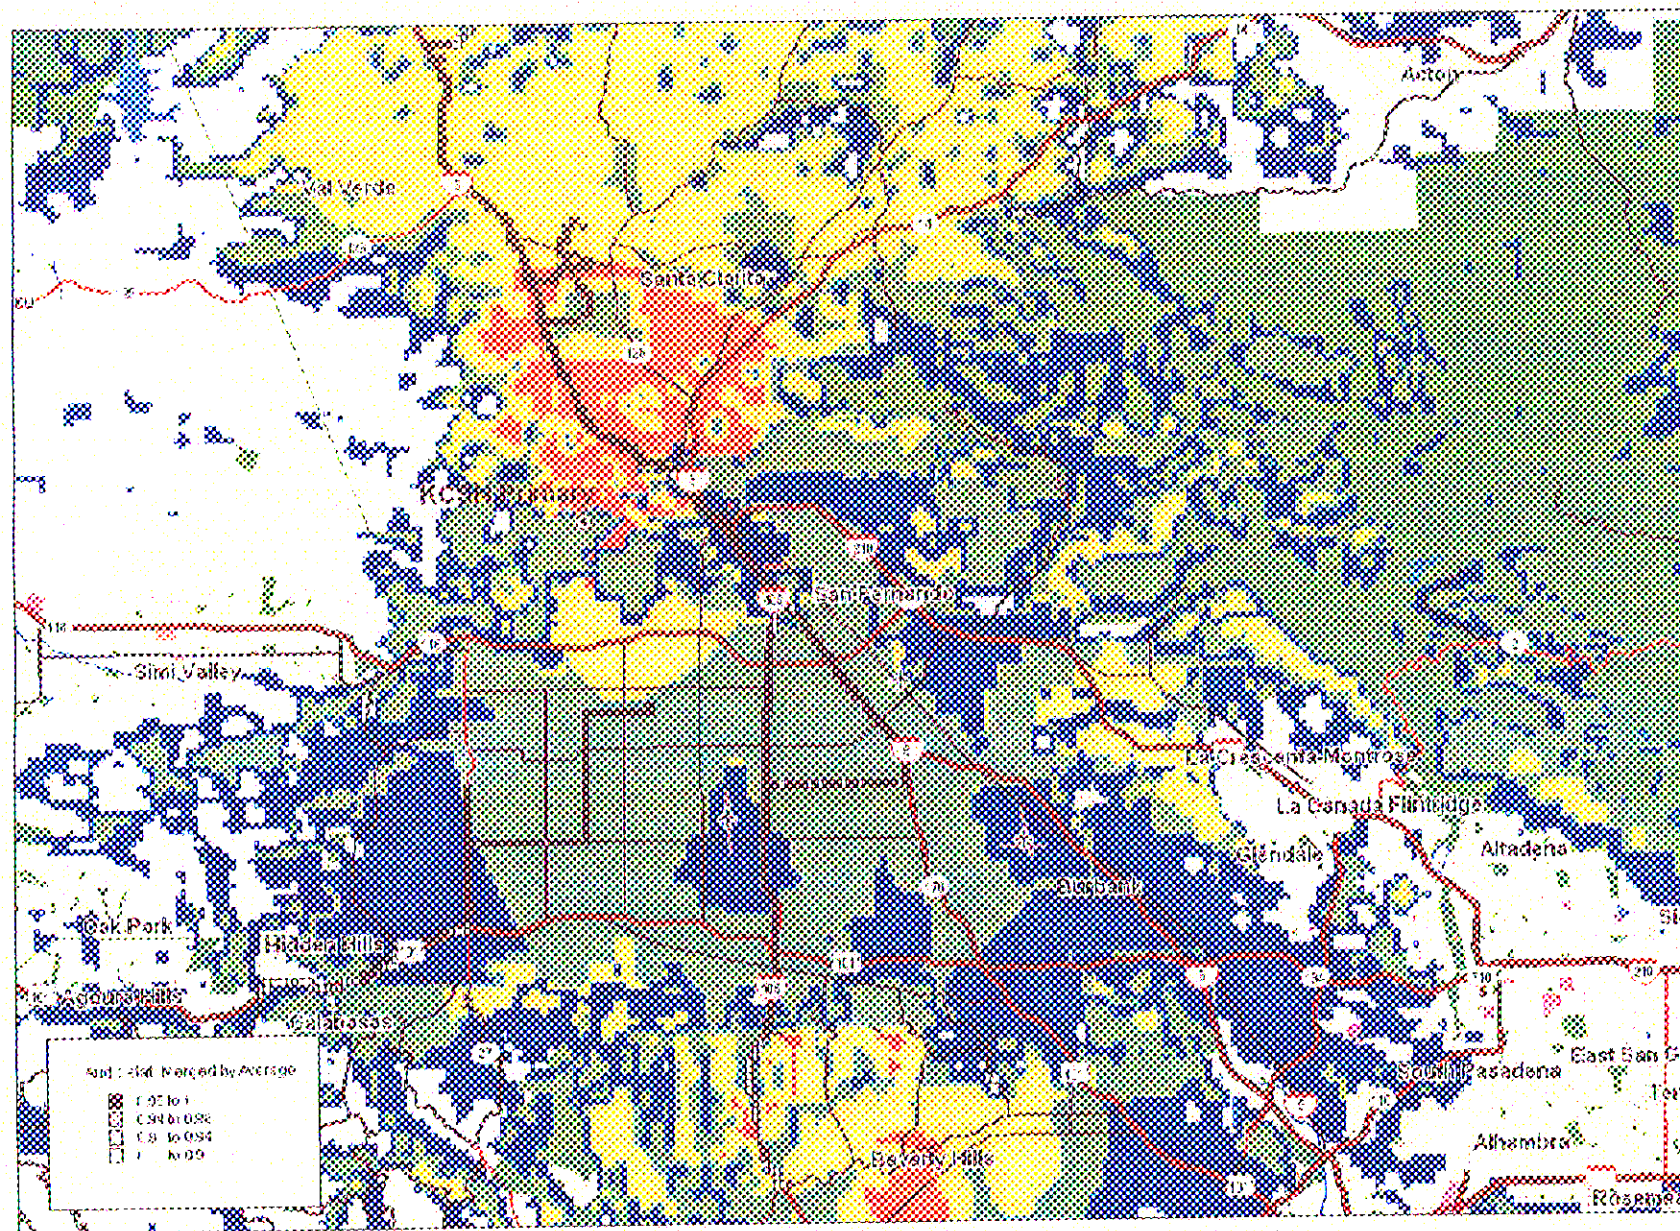
Figure 6 -HD Radio receive status as a locally-binned percentage (black representing >98% availability) with Longley-Rice field strength prediction.

For HD Radio performance in this area, shown in Figure 6, the grid block's shadings represent the reception availability. Black blocks represent successful reception at least 98% of the time, a figure that may correspond to an acceptable level of service for non-blended SPS programming. Gray blocks represent reception reliability between 90% and 98% of the time. White blocks represent reception reliability below 90% of the time.

HD Radio availability is high over most of the route, including Northridge, Simi Valley, San Fernando, Van Nuys, and Santa Clarita. Examination of the route along Interstate 405, south of the intersection with US Highway 101, shows sudden and persistent loss of HD Radio signal. This area of the route passes through the Santa Monica Mountains, which drops the received signal levels below 60 dBu as indicated in Figure 5.

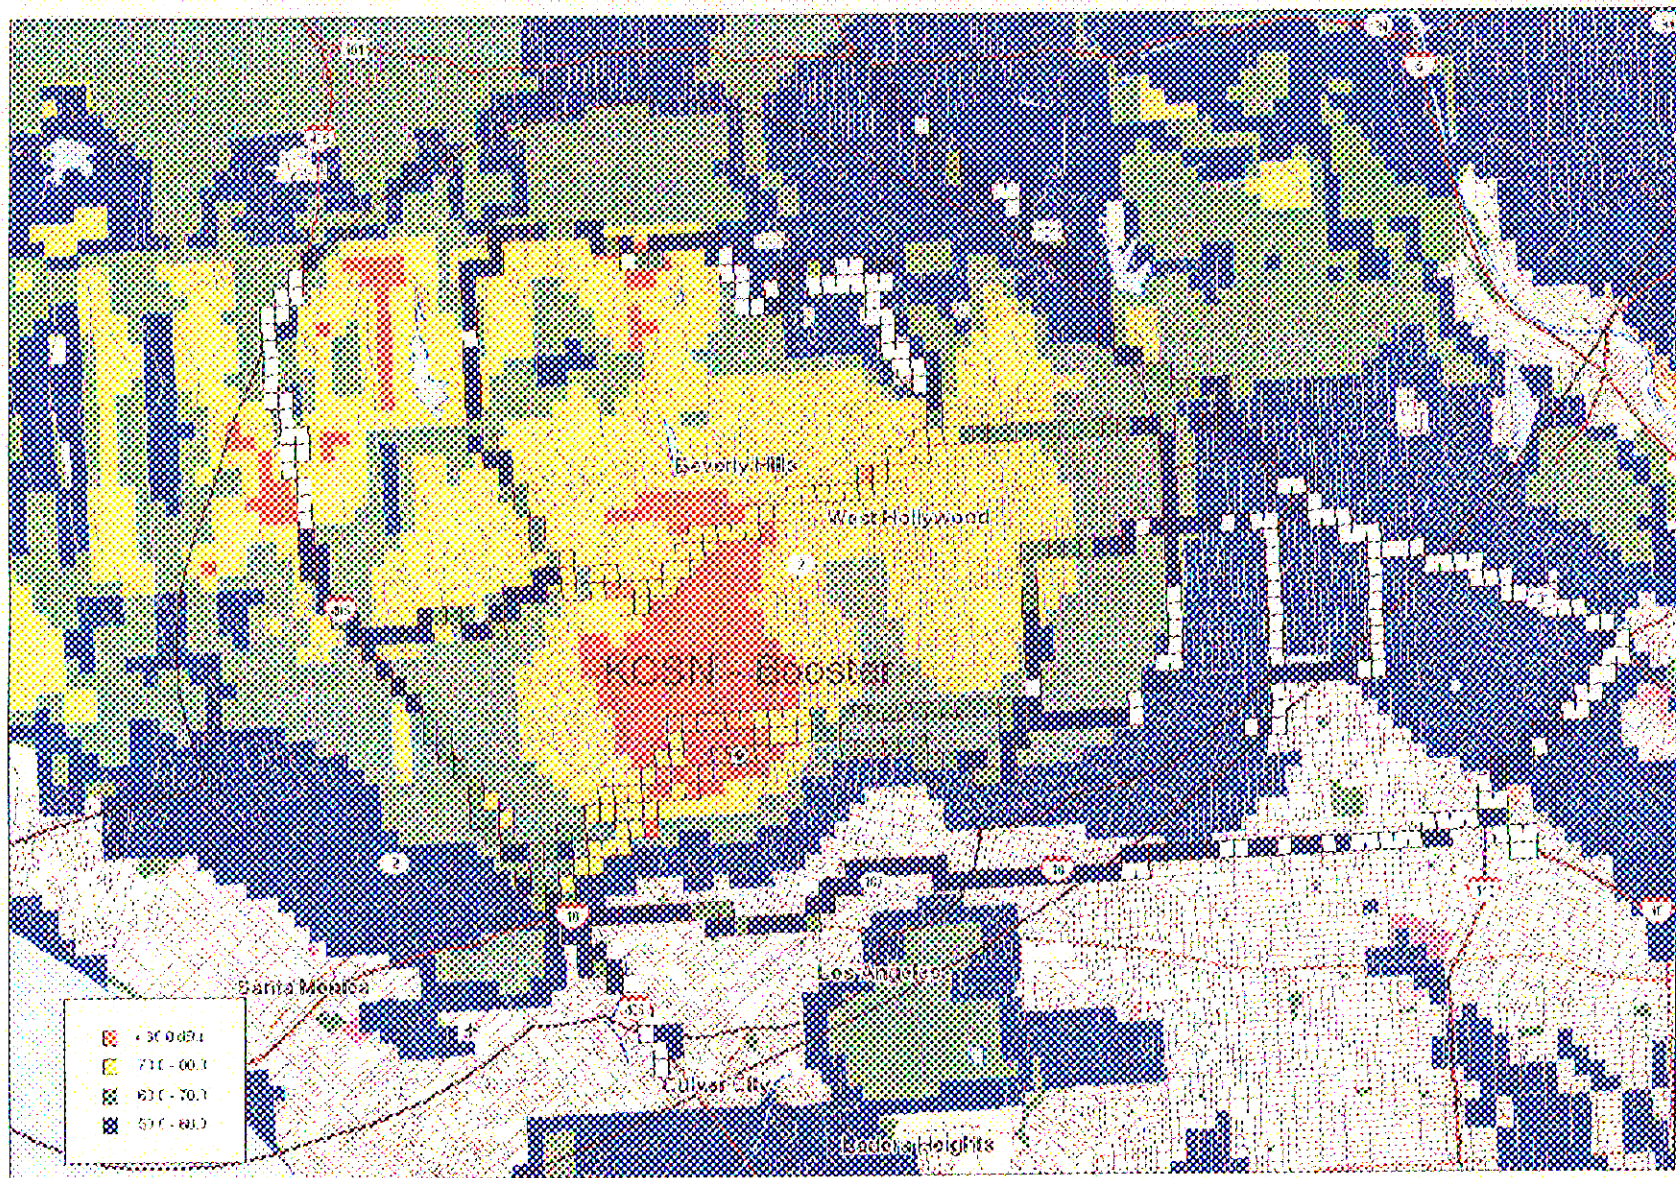
Figure 7 ~ Drive test RSL (approximate) displayed with Longley-Rice field strength predictions for KCSN primary and booster.

Figure 7 and Figure 8 are closer views of drive tests around the KCSN Booster site. The correlation between measured and predicted RSL is poorer in this area, with measured signal trending below predicted. Part of this is due to the extent of building clutter in the urbanized areas of Beverly Hills and Hollywood, which reduces the local signal more than the prediction model allowed. To the east, near the routes of US-101, I-110 and I-10, the signal levels are much lower than predicted, despite the roadways in these areas usually being elevated and clear of local building clutter. This difference may be due to pattern performance of the transmit antenna array at extreme angles off beam maximum or interactions with the building structure, or both.

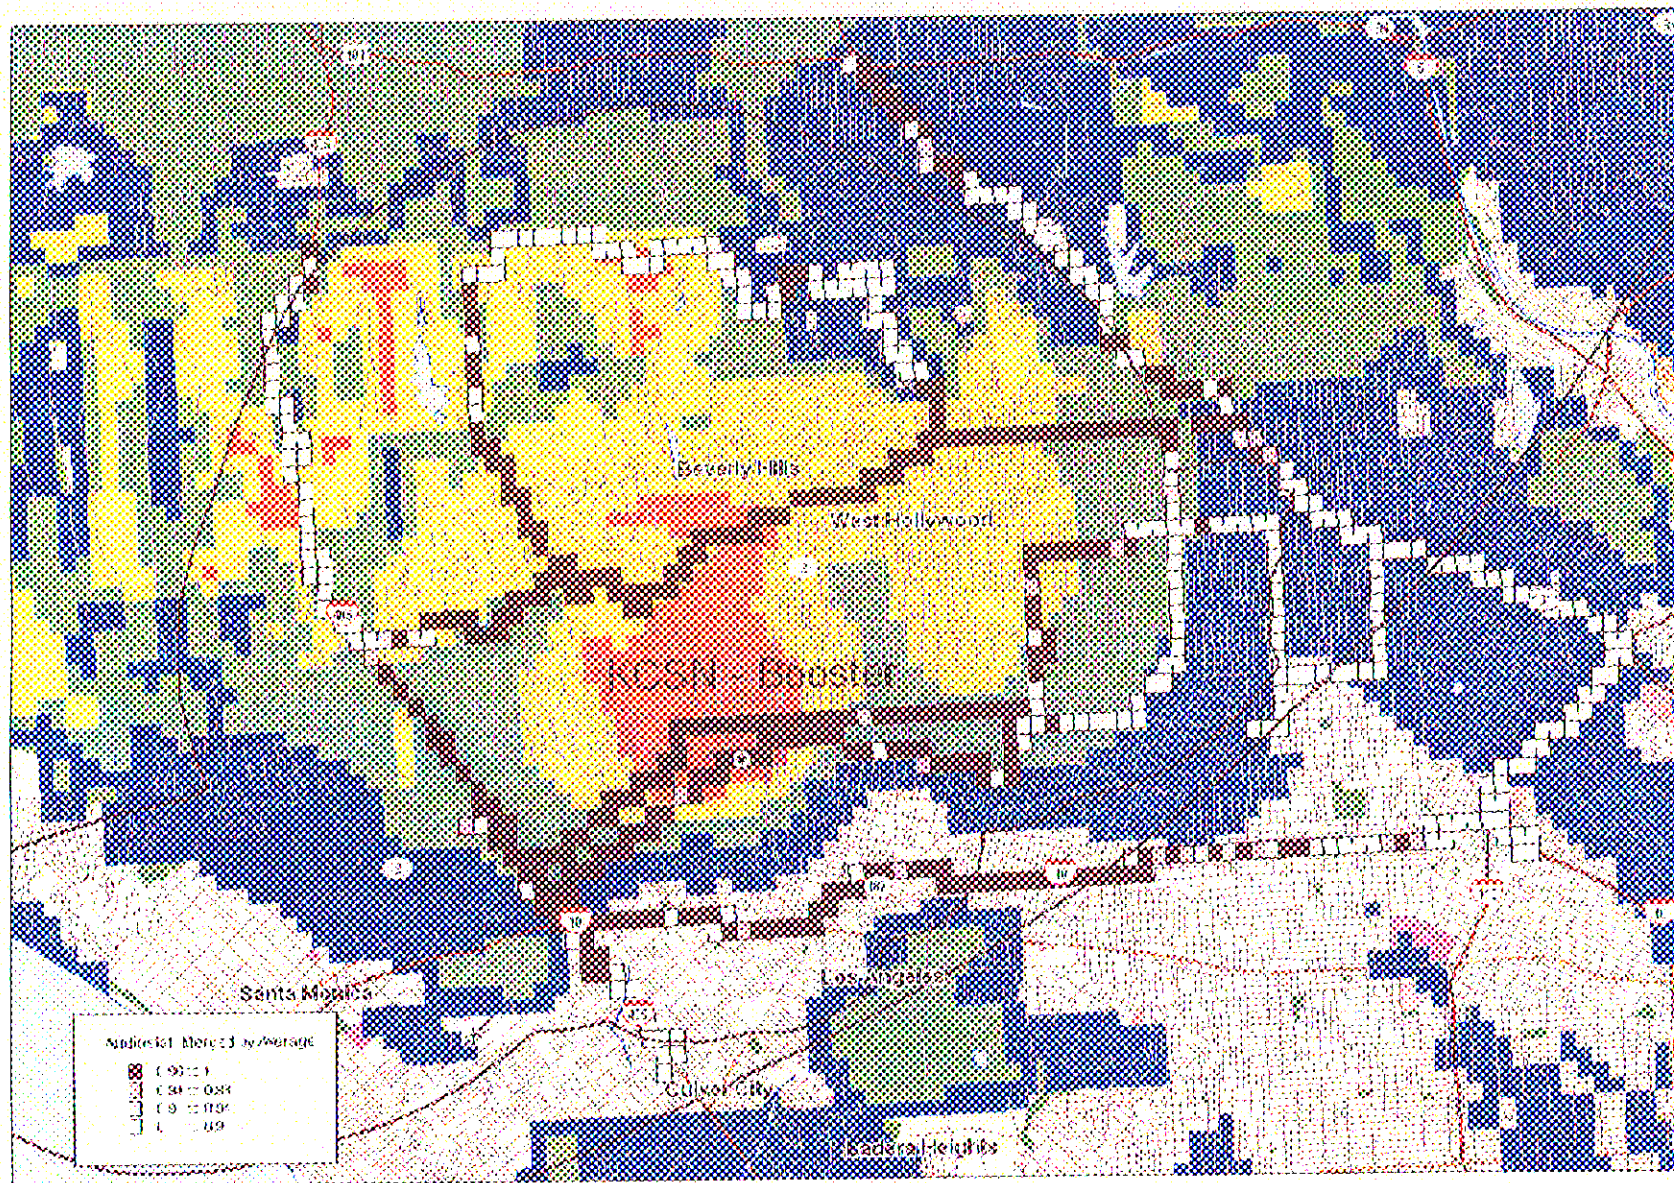
Figure 8 -- HD Radio receive status for the booster as a locally binned percentage of availability, shown with Longley-Rice field strength prediction.

Examination of the HD Radio coverage around the booster reveals poorer availability of reception, as a function of RSL, than in the Northridge area served by the primary transmitter. For example, Mulholland Drive, running west to east near the top of Figure 7 and Figure 8, experienced HD Radio availability well below 90% (white grid blocks), although the RSL was around 60 dBu. Low availability was experienced along part of US-101 and I-405, at RSLs that were acceptable in the primary transmitter coverage area. Examination of the drive-test data logs shows that these areas experienced HD Radio signals alternating between the booster and primary transmitter. (This is to be expected, as Mulholland Drive winds along the top of a ridge that receives signals irregularly from either primary or booster. Similarly, the northern part of US-101 is a wide pass through the Santa Monica foothills, which shares signals from the primary and booster).

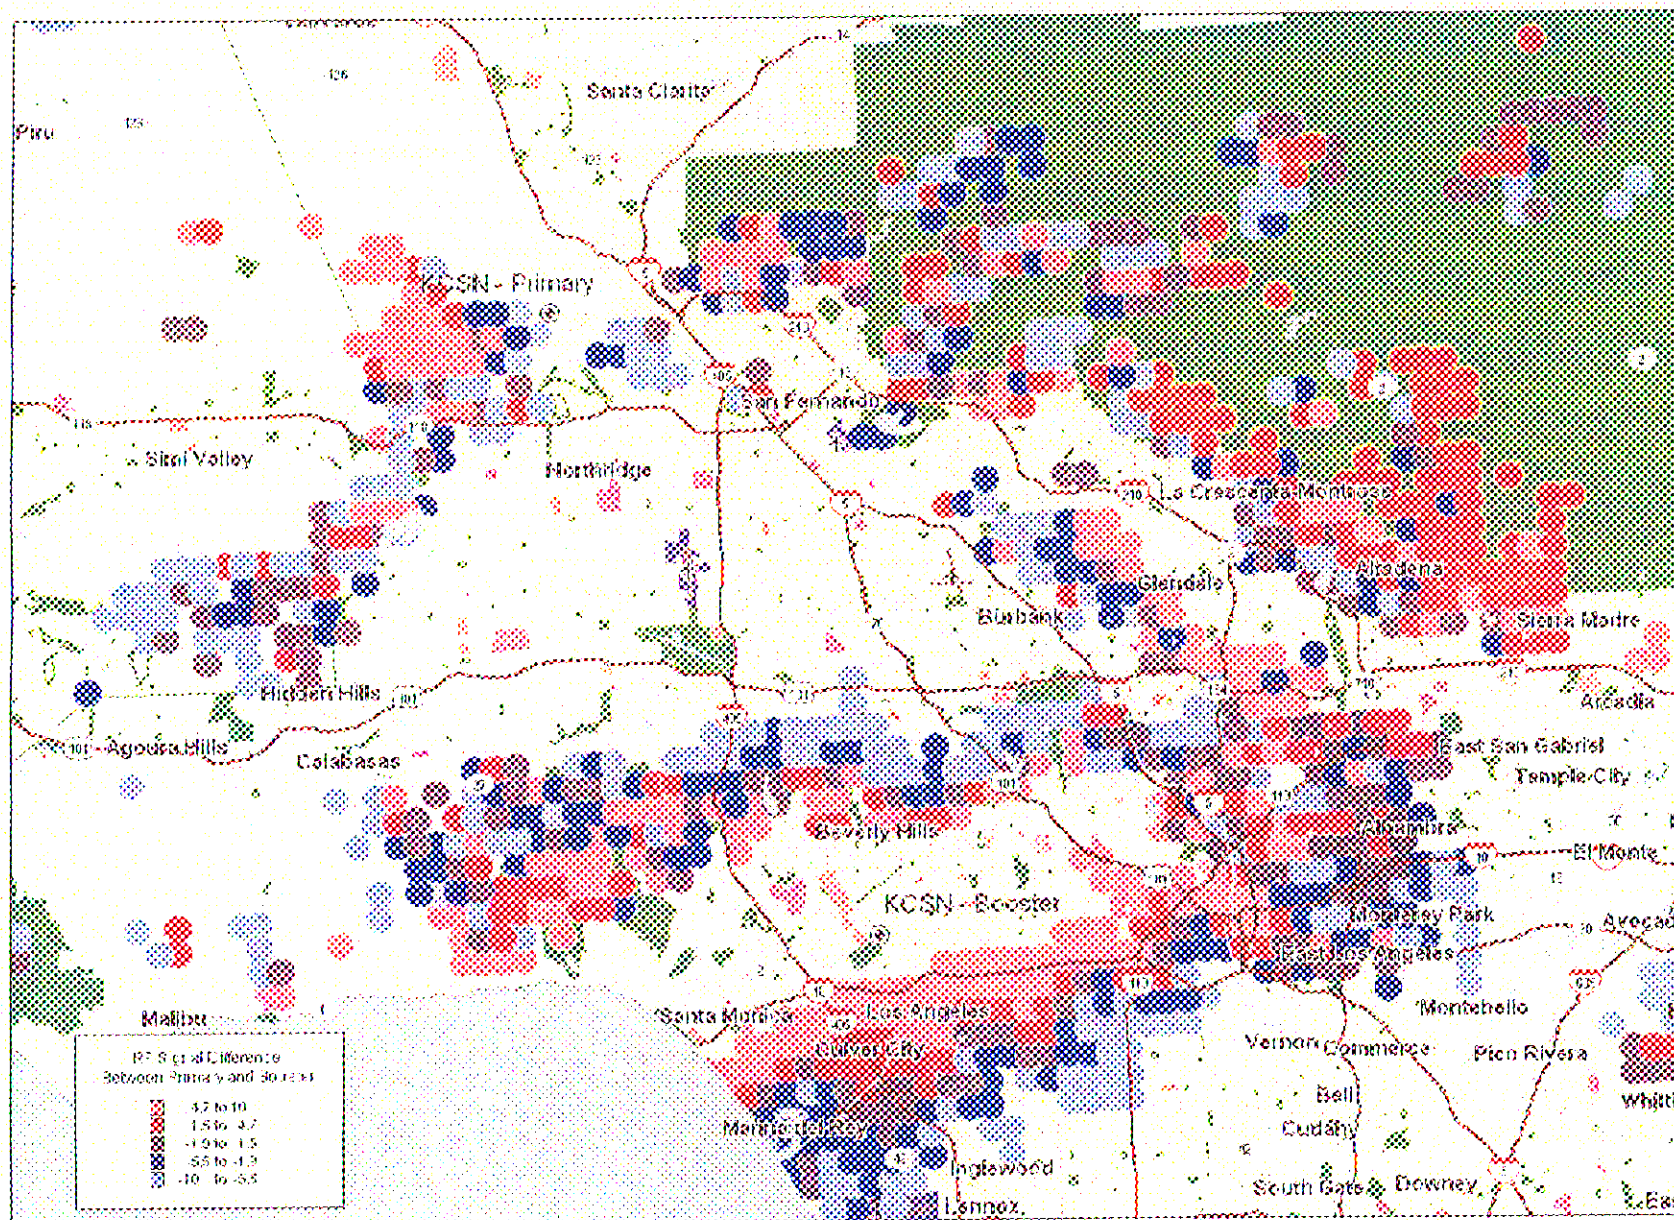
Figure 9 ~ Map showing areas where signals between booster and primary are within 10 dB and time-of-arrival differences are greater than 75 ns.

The map of Figure 9 helps explain why HD Radio availability is lower than expected in areas of RSL, which is a computation of predicted RSLs for both primary and booster. (Note that the scale of this map differs from the previous maps.) Locations where the ratio of primary and booster signals are within 10 dB, and the time-of-arrival differences

are greater than 75 microseconds are shown with colored dots.³ The dot colors simply show which signal is greater, and the magnitude of the RSL difference. However, the presence of the dots indicates a higher probability that HD Radio propagation delay interference would occur between the booster and the primary signals.

Due the physical distance between the KCSN primary and booster, signals near the booster arrive from the primary more than 100 microseconds later than those from the booster. Current design of the HD Radio system does not provide for an intentional timing offset of OFDM symbols at Layer 1, which would be necessary to correct for local generation of OFDM signals at the booster when primary signals arrive more than 75 microseconds late. The concurrent arrival of signals from primary and booster with large time differentials appears to be a source of the lower than expected HD Radio availability in KCSN's case.

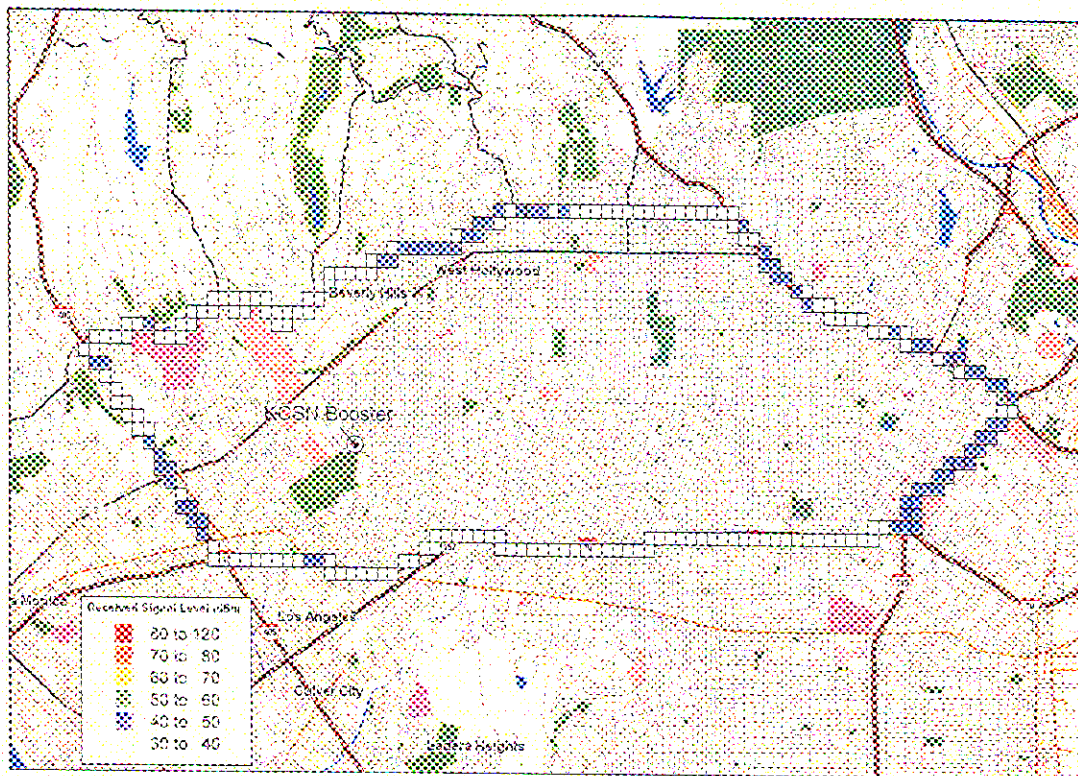
Figure 10 – Drive test RSL (approximate) with booster off.

The contribution of the booster to KCSN's signal coverage is apparent by comparing the maps of Figure 10 and Figure 11, which show results with booster "off" and "on" along a drive-test route around the booster. Comparison of local mean RSLs from each map shows increases of 20 to 40 dB at many locations, and more than 40 dB in some locations north of the booster. The audible effect on service between booster off and booster on was often the difference between no usable signal and a very listenable stereo signal.

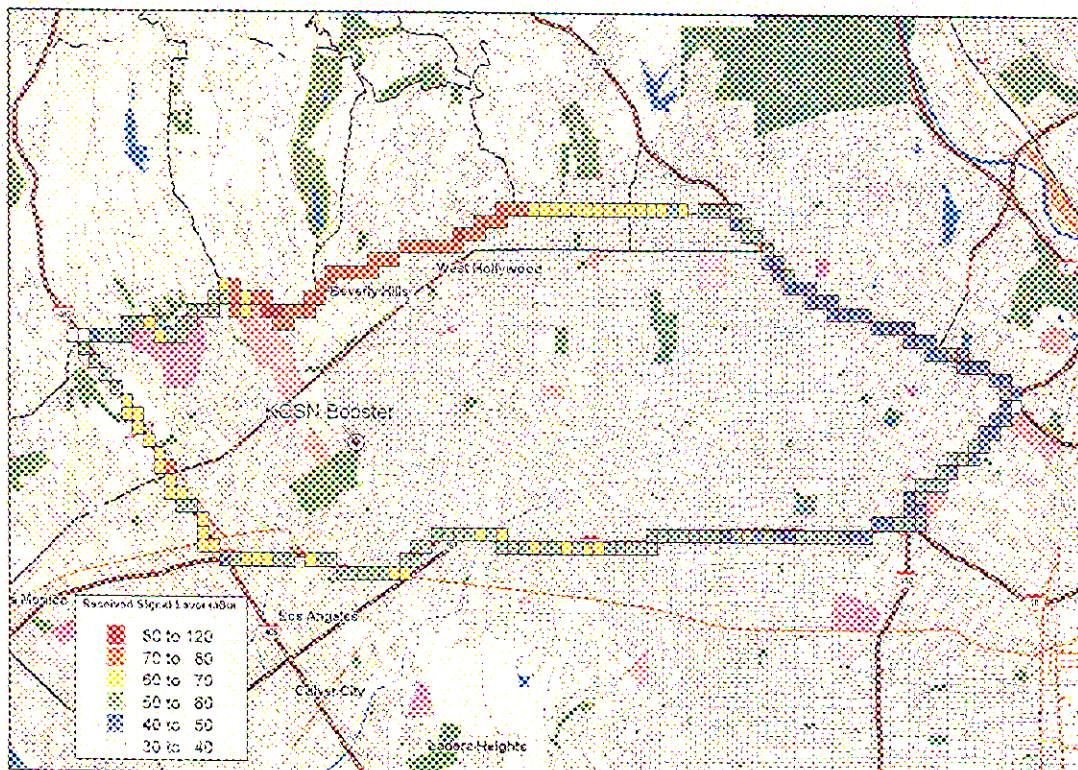
Figure 11 – Drive test RSL (approximate) with booster on.

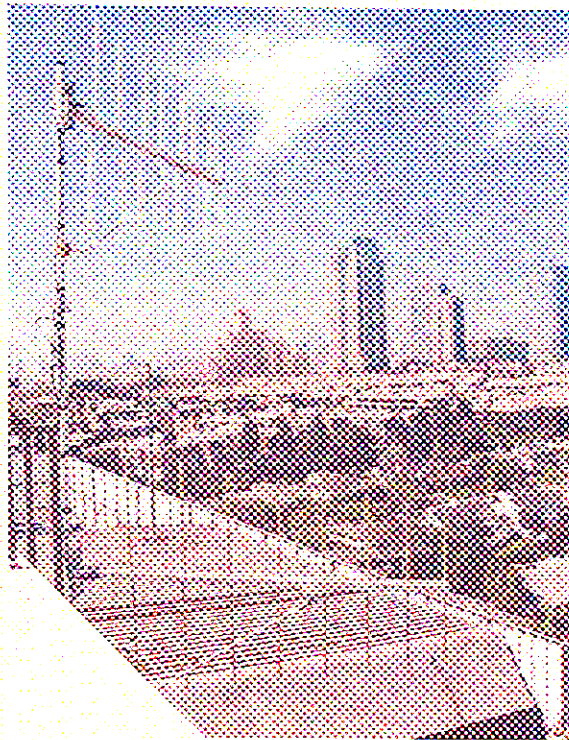
Figure 12 – Transmitting antennas of KCSN booster are vertically polarized log-periodic units oriented to the northwest (upper) and northeast (lower). A power splitter (box mounted on pole) provides equal power and phase to the antennas. Downtown Beverly Hills is visible in the distance.

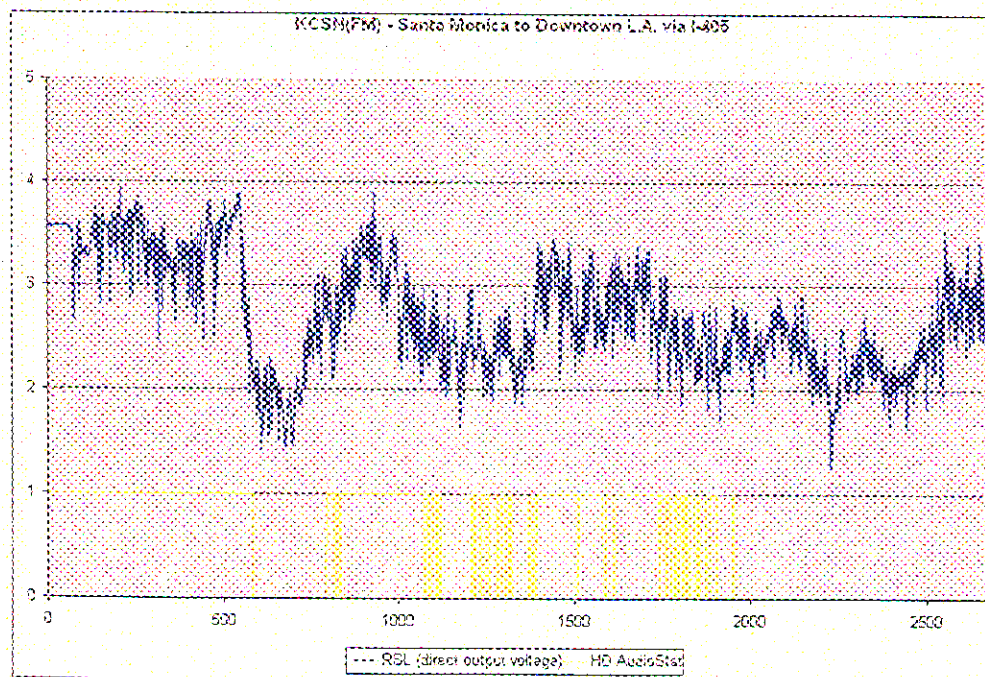
Figure 13 – Example of Received Signal Level and HD receive status collected during a drive-test; a “1” indicates successful HD reception on the yellow graph line; “0” indicates no HD reception.
